Ice/Frost/Debris Assessment For Space Shuttle Mission STS-27R

(NASA-TM-102144) ICE/FROST/DEBRIS
ASSESSMENT FOR SPACE SHUTTLE MISSION
STS-27R, DECEMBER 2, 1988 (NASA) 200 p
CSCI 22B

ICE/FROST/DEBRIS ASSESSMENT
FOR
SPACE SHUTTLE MISSION
STS-27R
DECEMBER 2, 1988

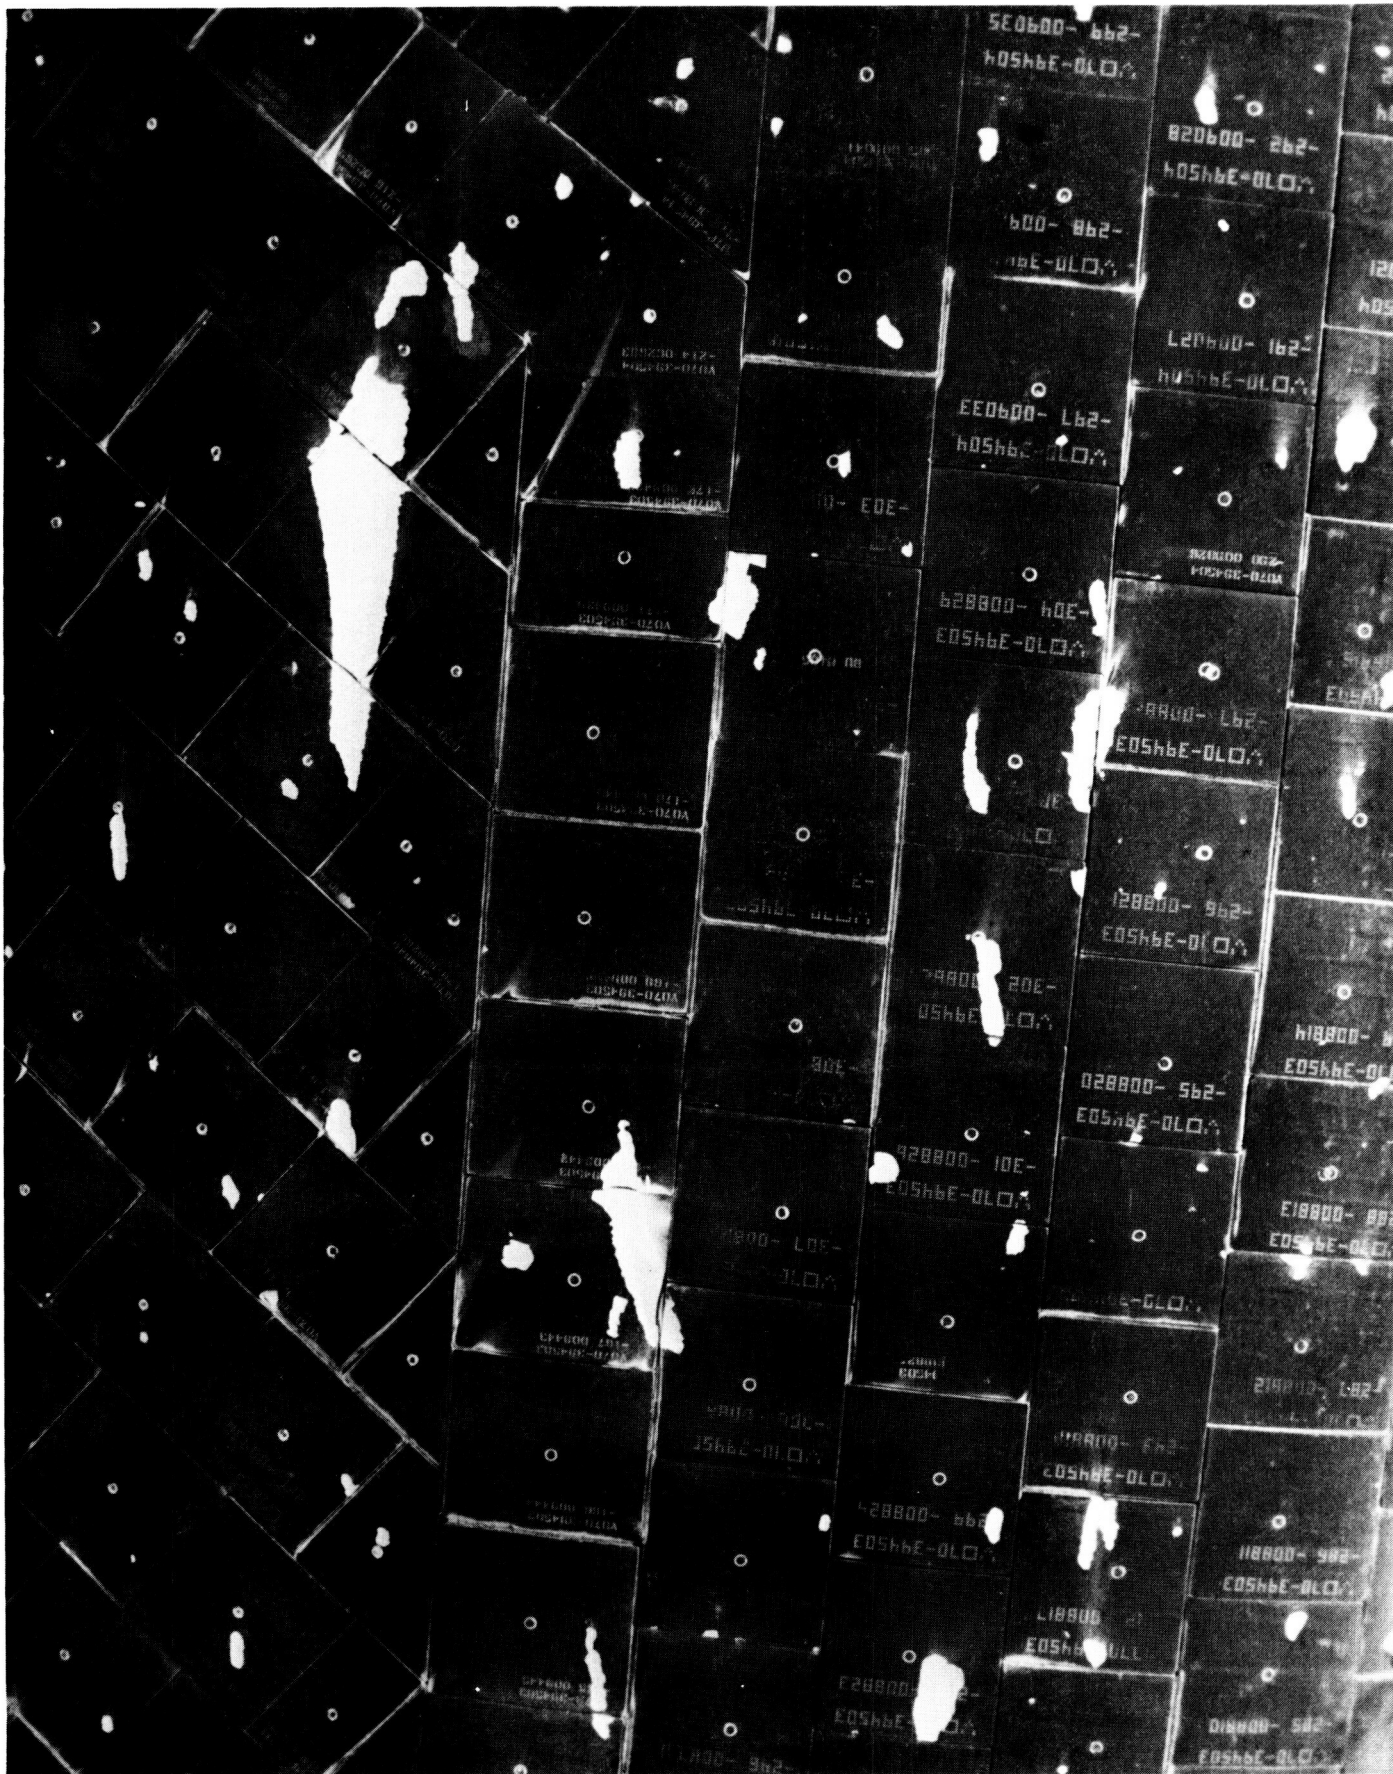
STRAIGHT LINE PATTERN OF DEBRIS DAMAGE
TO TILES ON RH LOWER MID-FUSELAGE

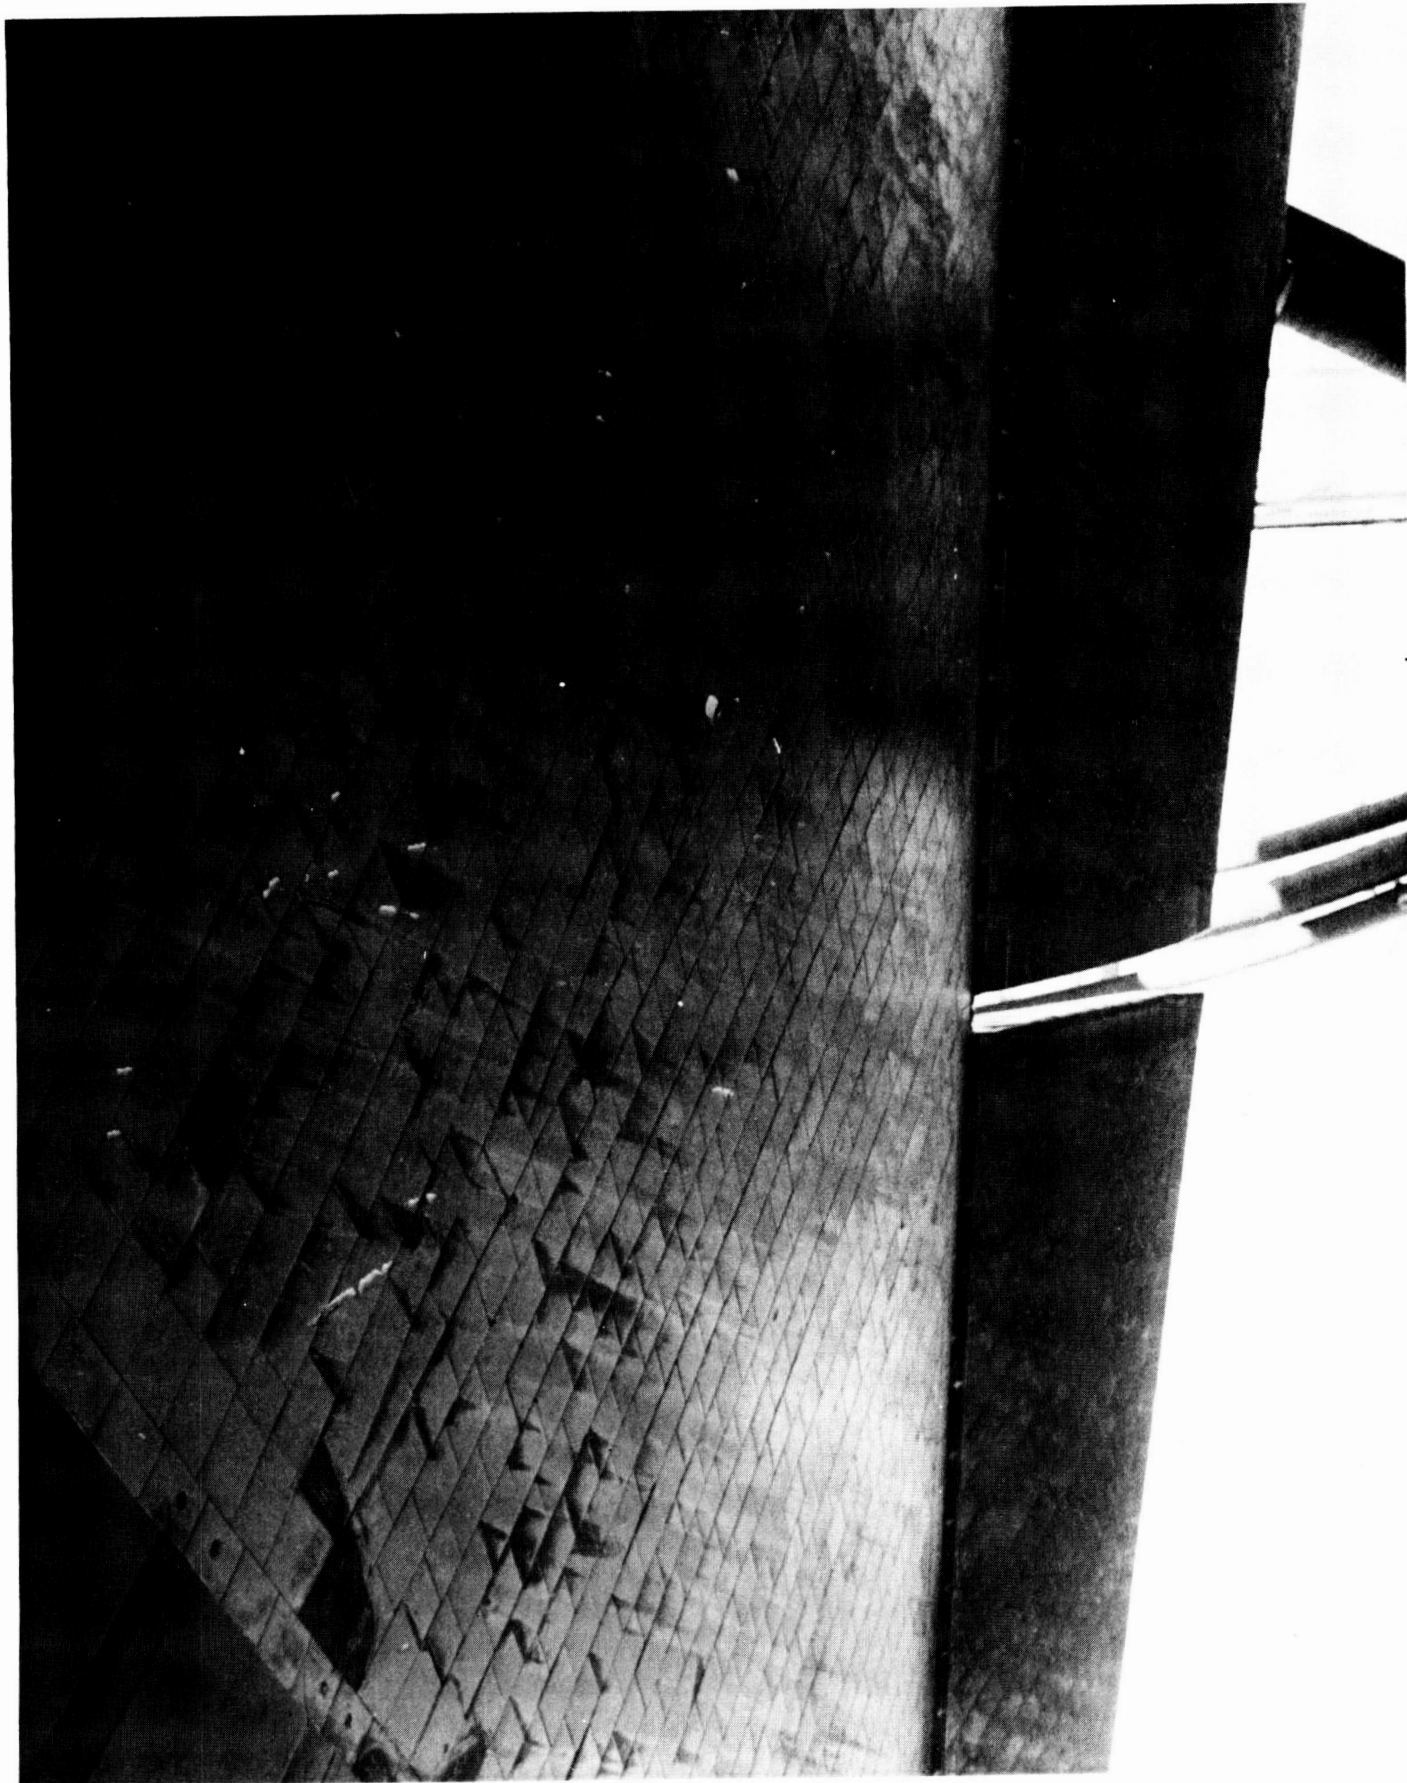
DAMAGE STREAKS ON RH WING LOWER SURFACE.
NO DAMAGE TO RH ELEVONS.

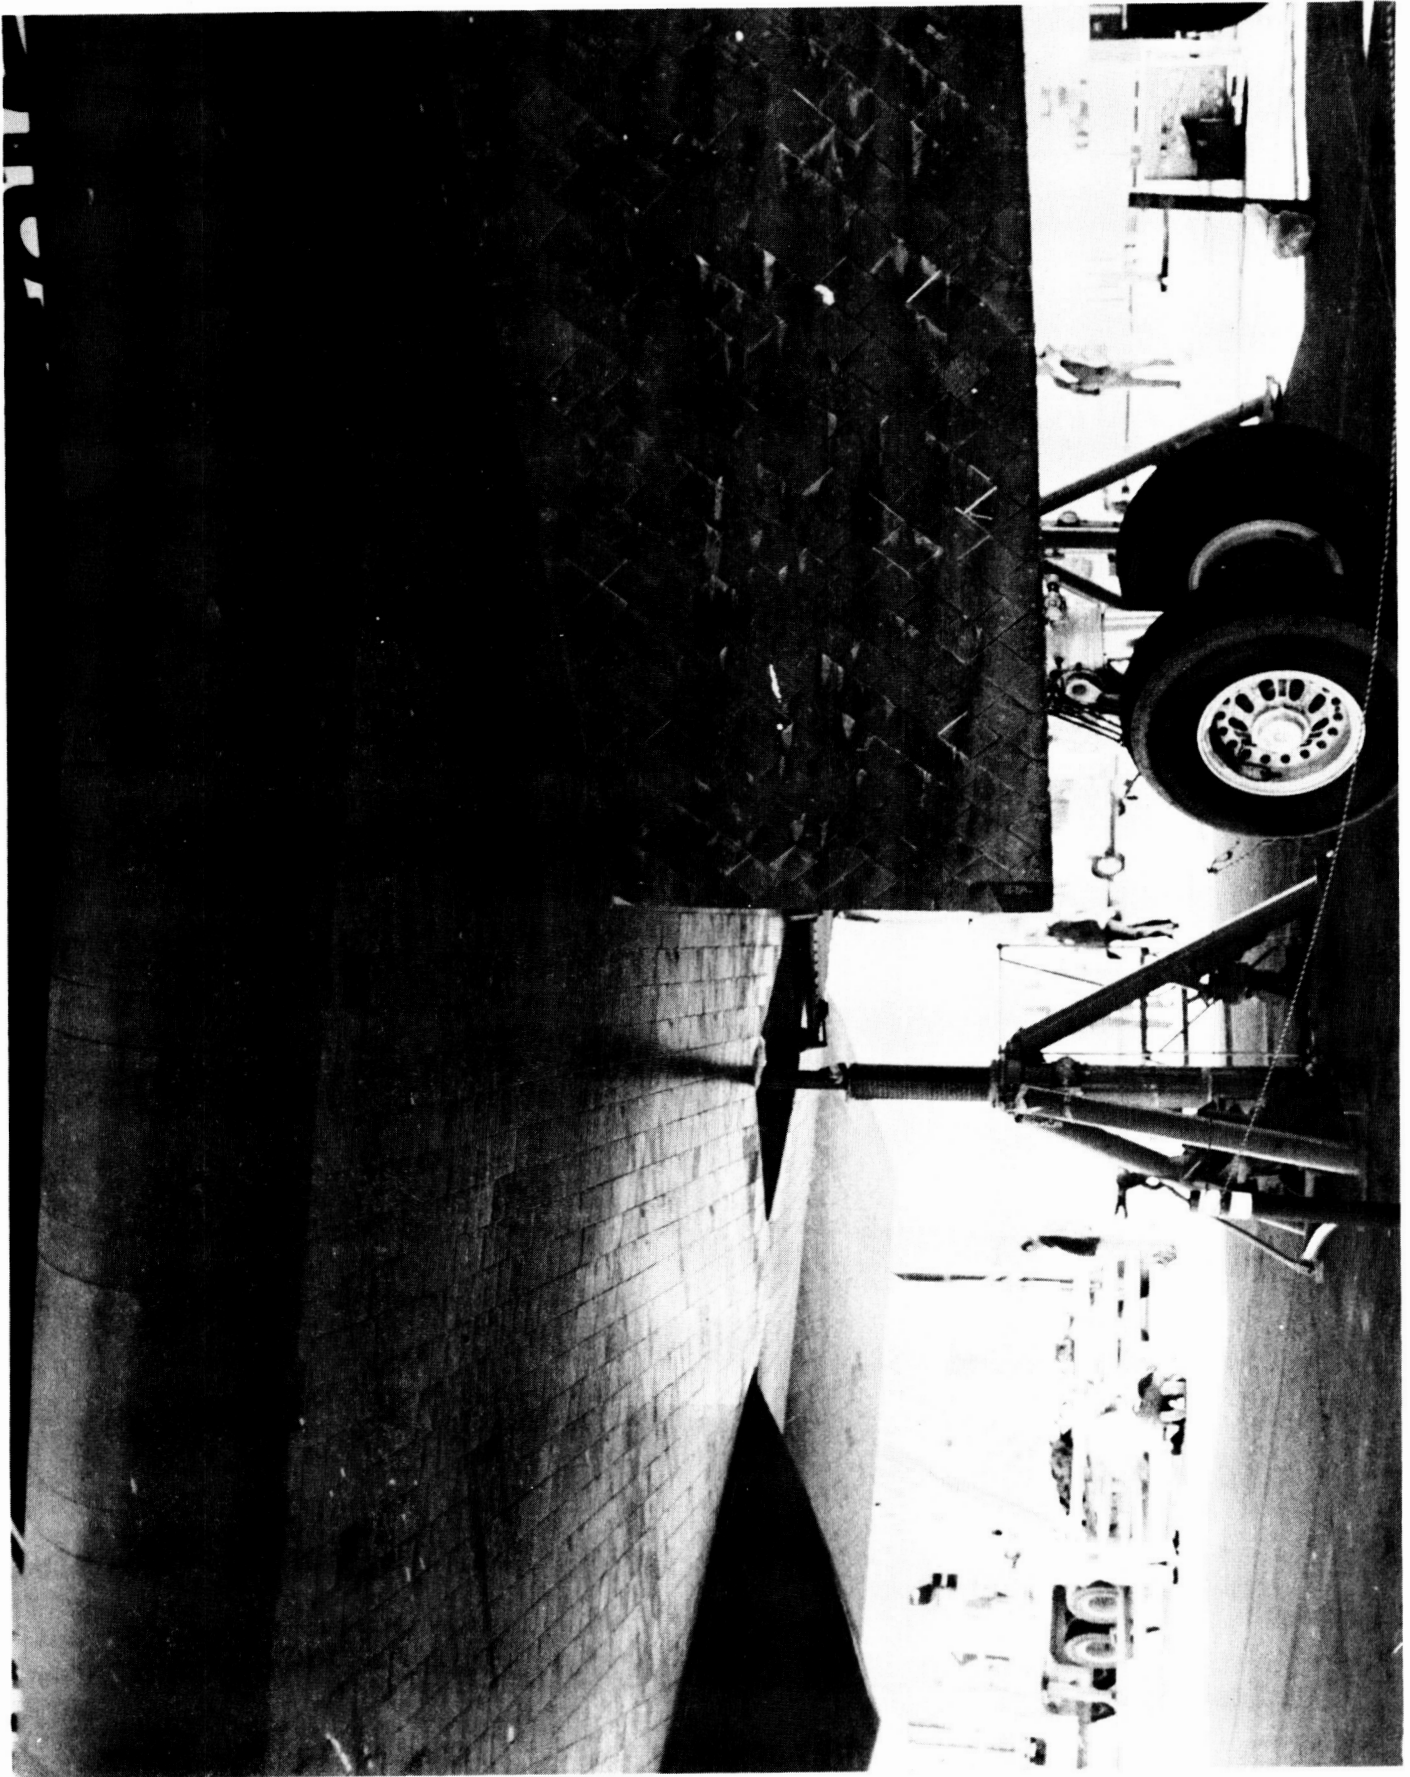
STREAKS ON RH WING RCC LEADING EDGE. DAMAGE TO
RH WING LOWER SURFACE AND RH MLG DOOR.

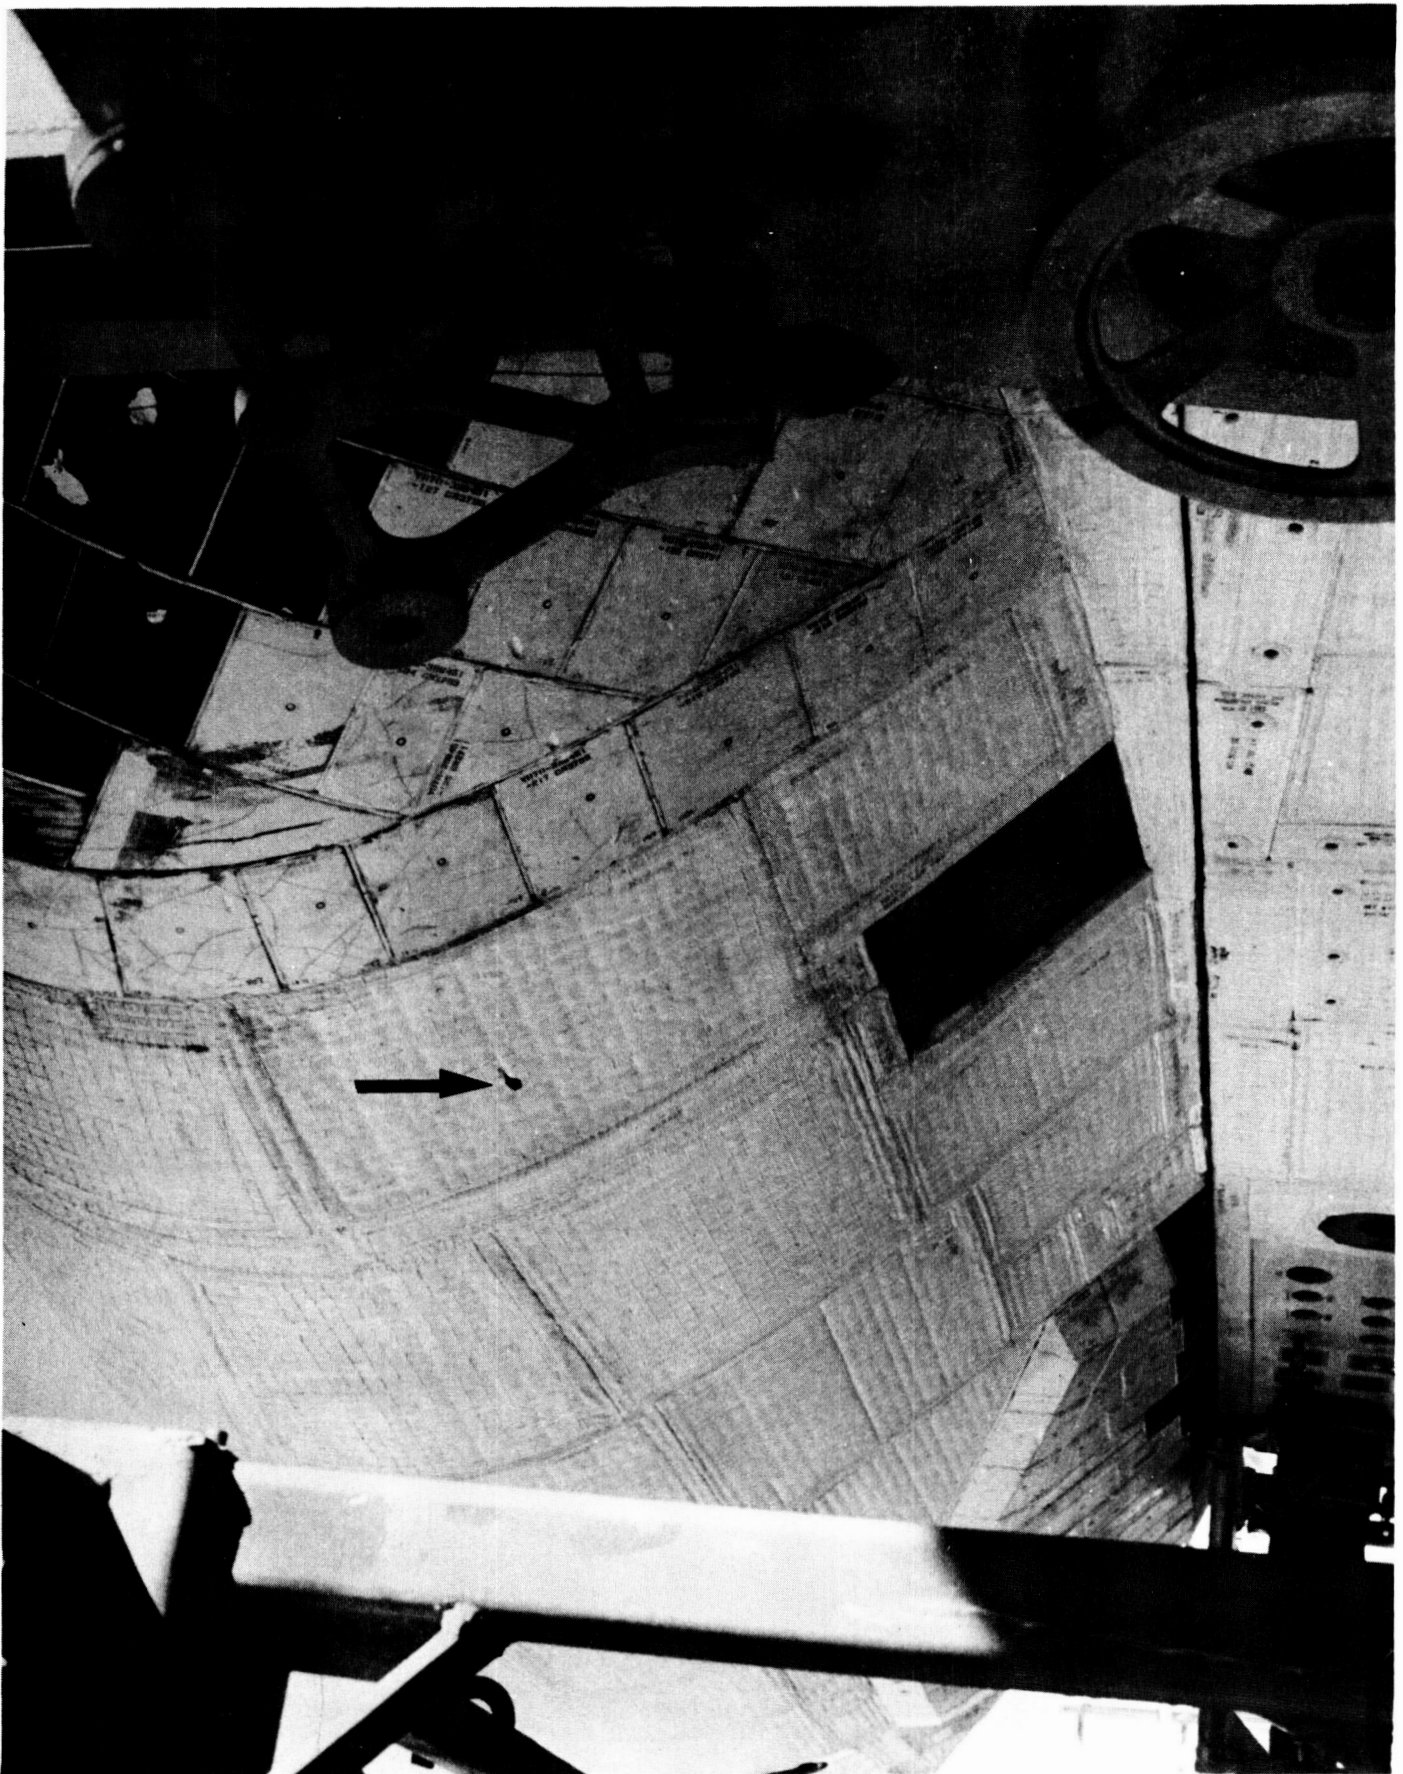
A fiberglass carrier panel V070-396403-002 installed on the door which covers attach point #9 of the RH OMS pod was missing from its position midway along the lower outboard edge of the pod. Damage to the surrounding area (abrasion and impact signs on the blanket immediately aft of the missing panel location) and launch photography confirm the panel was lost during ascent. However, there was no evidence of heat related damage to the door or to the surrounding structure. A closer inspection in the MDD revealed that the sleeve bolts and the retaining rings were still attached to the door, but no flat washers or carrier panel fragments were present. Investigation by PR determined the torque values were acceptable at 5 of 6 locations and slightly low at position 5. Fastener-to-structure measurements show that all fastener heads were embedded into the panel due to the lack of flat washers and that the lower leading edge corner fastener was torqued completely through the panel. The fasteners, removed and measured for length, were shorter than the drawing requirement. Measurement of the retaining rings confirmed that the improper type had been installed. The purpose of the retaining ring in this type of fastener is to permanently secure the sleeve bolt to the panel. Omission of the flat washers greatly reduced the fastener bearing area on the panel and caused the fasteners to be torqued into and through the panel. This condition was aggravated by the incorrect grip length, which allowed the fasteners to be torqued into the panel rather than shanking out. The incorrect retaining rings prevented the panel from seating flush to the door and may have allowed airflow to intrude and lift the panel. The carrier panel had been installed on the OMS pod per a job card that called out the correct hardware. However, the installation of the captive fasteners into the panel had been done to an

LOCATION OF MISSING RH OMS POD CARRIER PANEL, TILE DAMAGE
BY ASCENT DEBRIS, AND DEEP AFRSI PENETRATION.

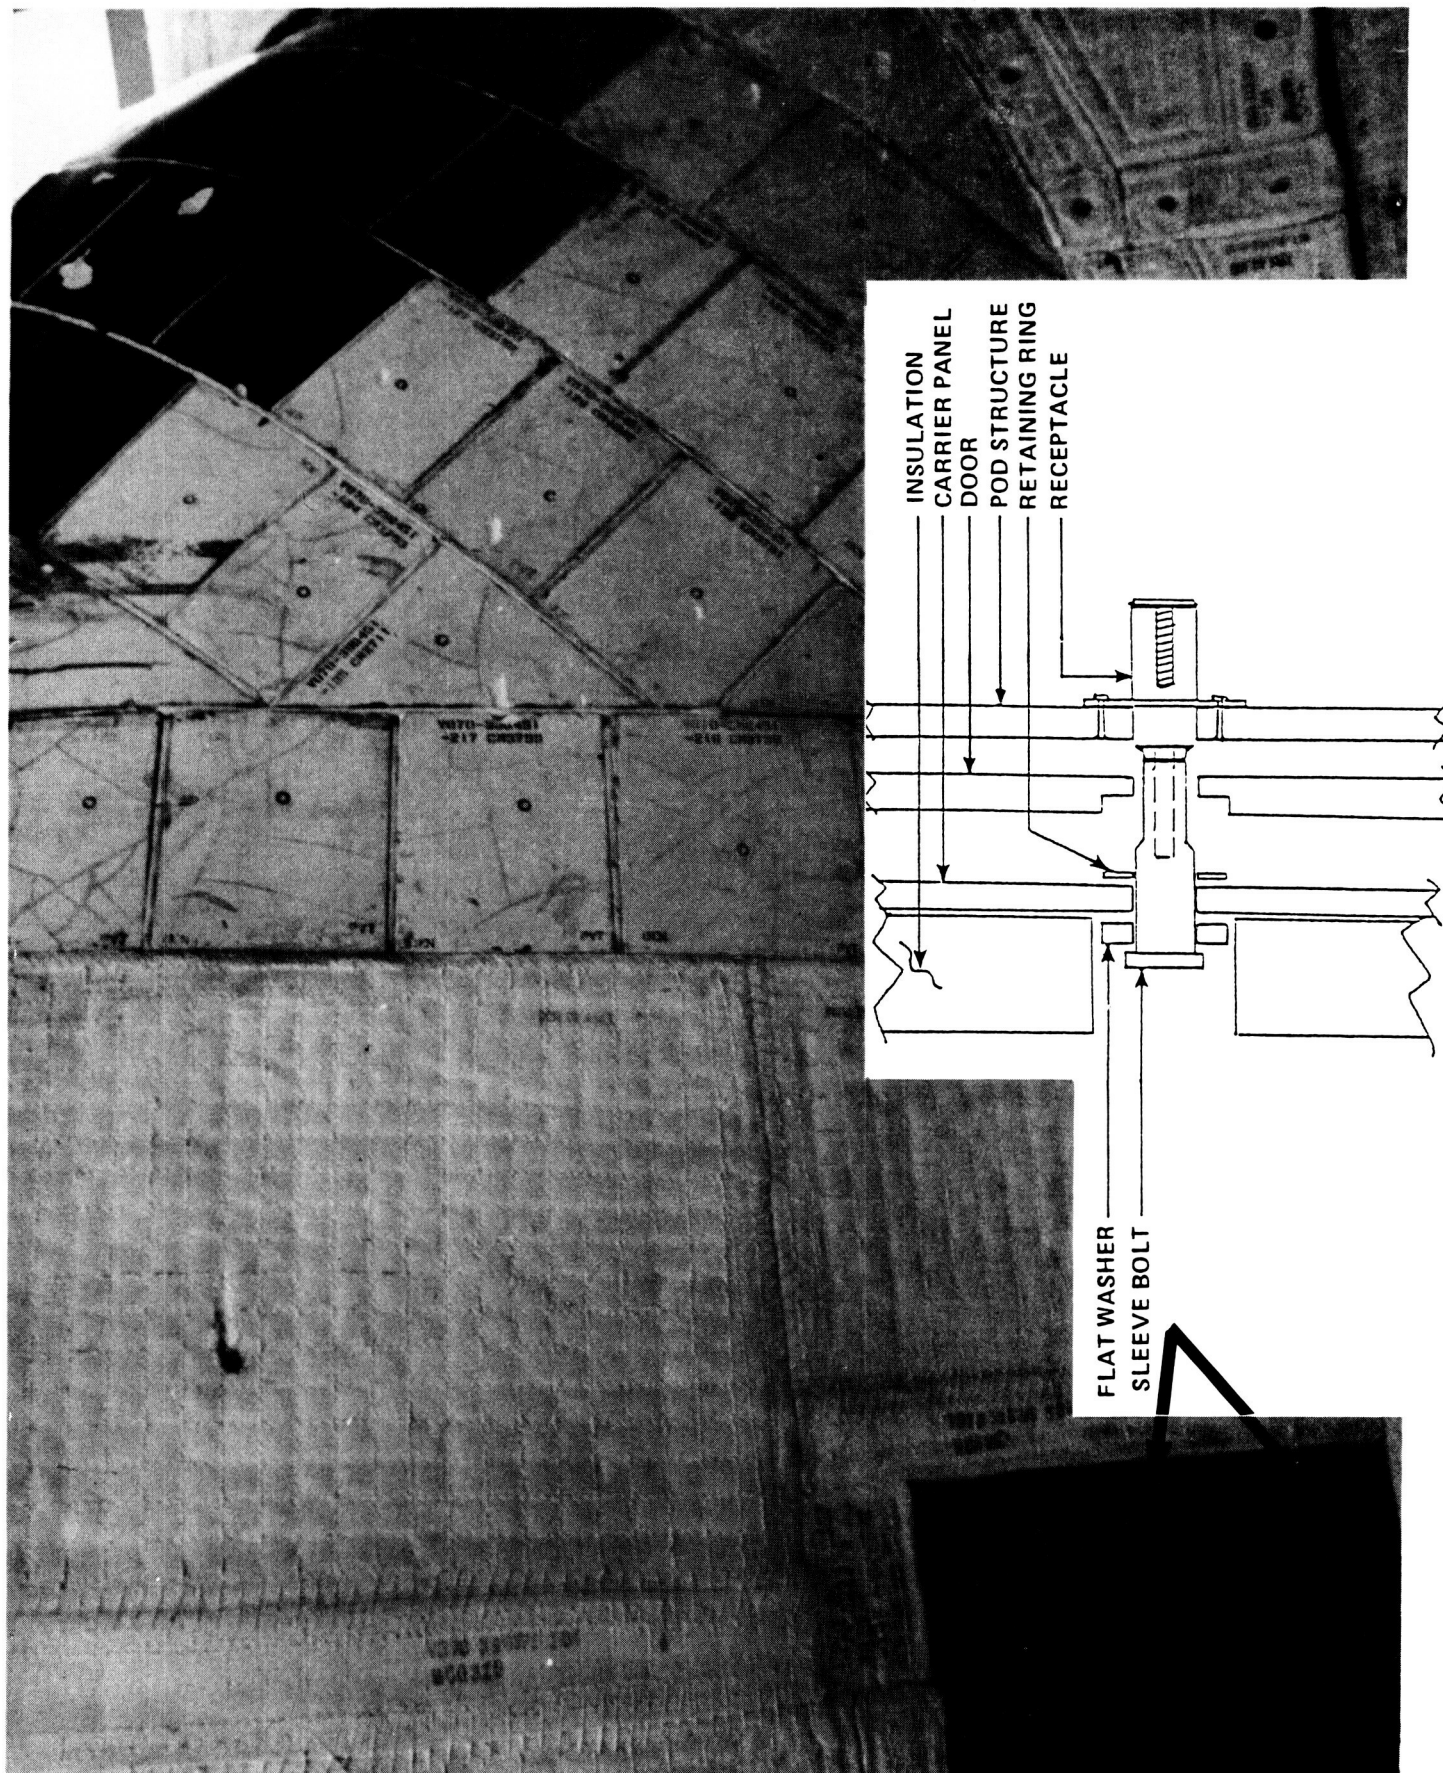
DETAIL OF IMPROPERLY INSTALLED PANEL BOLTS. TILES WERE DAMAGED
BY DEBRIS. DEEP DEBRIS PENETRATION OF AFRSI IN UPPER LEFT AREA.
